EXPERIMENTAL EVALUATION REPORT

Thin-Whitetopping Bonded Composite

Location: Glendive, Montana – Dawson County

Project No.: STPP 20-1(6)0, P-20, C000020; Highway 16, Milepost 0-0.6

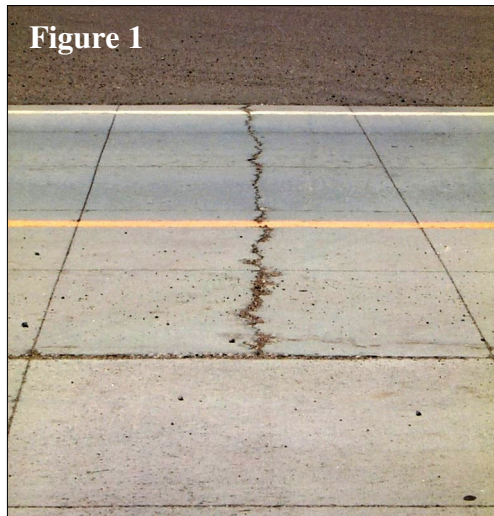
Figure 1

A visual inspection of the entire project was performed to document all types of surface cracking and distress. Photographic documentation of some of the cracks, recent repairs, as well as a representative crack map is included in this report. Note that the crack map is strictly an interpretation of progressive distress during the evaluation phase of the project, it is not to scale. Currently three transverse cracks are present on this project, all in the southbound lane. Location as follows (footage counted from the south end of the project going north), #1 at 1244' (541m), #2 at 1380' (420m), and #3 at 1480' (451m), see crack map at end of report. Note that these cracks developed soon after placement during construction. These cracks have widened since construction and are rated as severe in nature (example of crack in figure 1). Incompressible debris (rocks, friables etc,) is entering the cracks and will accelerate the deterioration of the fracture with freeze thaw events, however no debonding of the asphalt and PCCP layer was observed with any of the existing transverse cracks in this evaluation. No additional transverse cracking has occurred since construction.

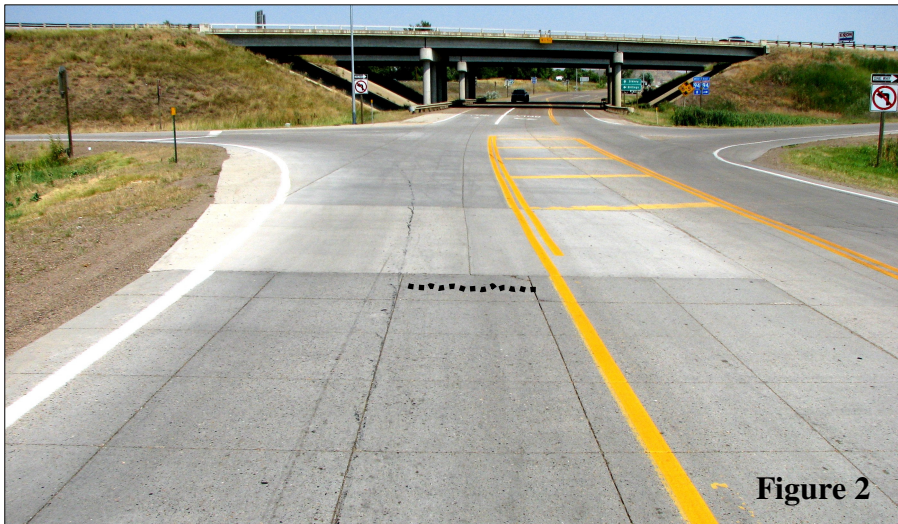
Figure 2

A total of approximately eighteen panels have cracked since construction. A cracked panel does not necessarily mean a failure of the bond between the AC and PCCP layers. To date, no panel movement or

Fifteen panels were affected at the north and south end of the project on the southbound lane. In fall of 2005 both these areas were repaired due to the extent of the panel cracking. The repair involved removal of the existing PCCP and asphalt layers and replaced with full-depth PCCP.

During this analysis several more panels have cracked, located at the north edge of the southbound lane of the project; adjacent to the recent full-depth repair (figure 2, crack panel shown as black line in image). In this type of cracking which

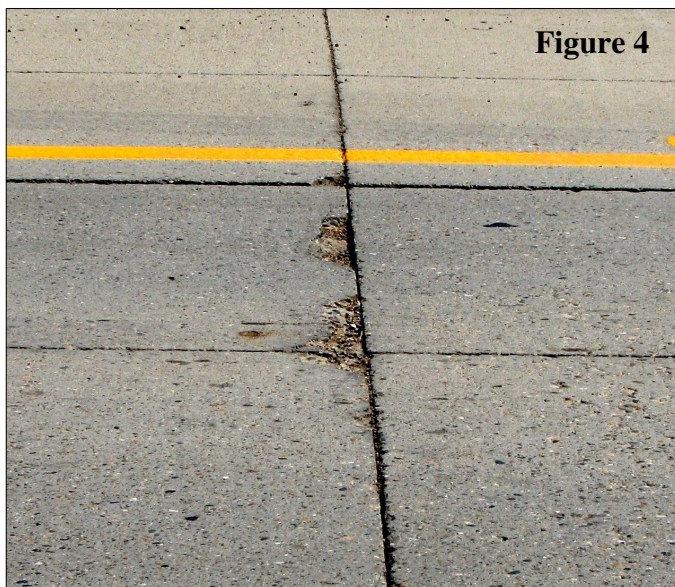
is indicative of this kind of pavement treatment, without an autopsy of the panel, it is difficult to determine the various causes of cracking. It could entail debonding of the PCCP from the asphalt concrete, structural failure of the underlying AC layer, which visually, has not been seen, or possibly overloading of the composite panel or sympathy cracking. In addition, panels that have previously cracked are at or near the curb edge adjacent to areas where turning movements of heavy trucks are traveling onto the gravel curb and onto the edge of the PCCP pavement. The lack of support may have allowed

cracking at these locations (refer to the crack map at the end of this document). Figure 3 (located midway on southbound side) shows how the lack of curb supports can allow panels to crack from heavy loadings. Though not apparent in this photograph the south adjacent panel has also cracked and will continue to degenerate.

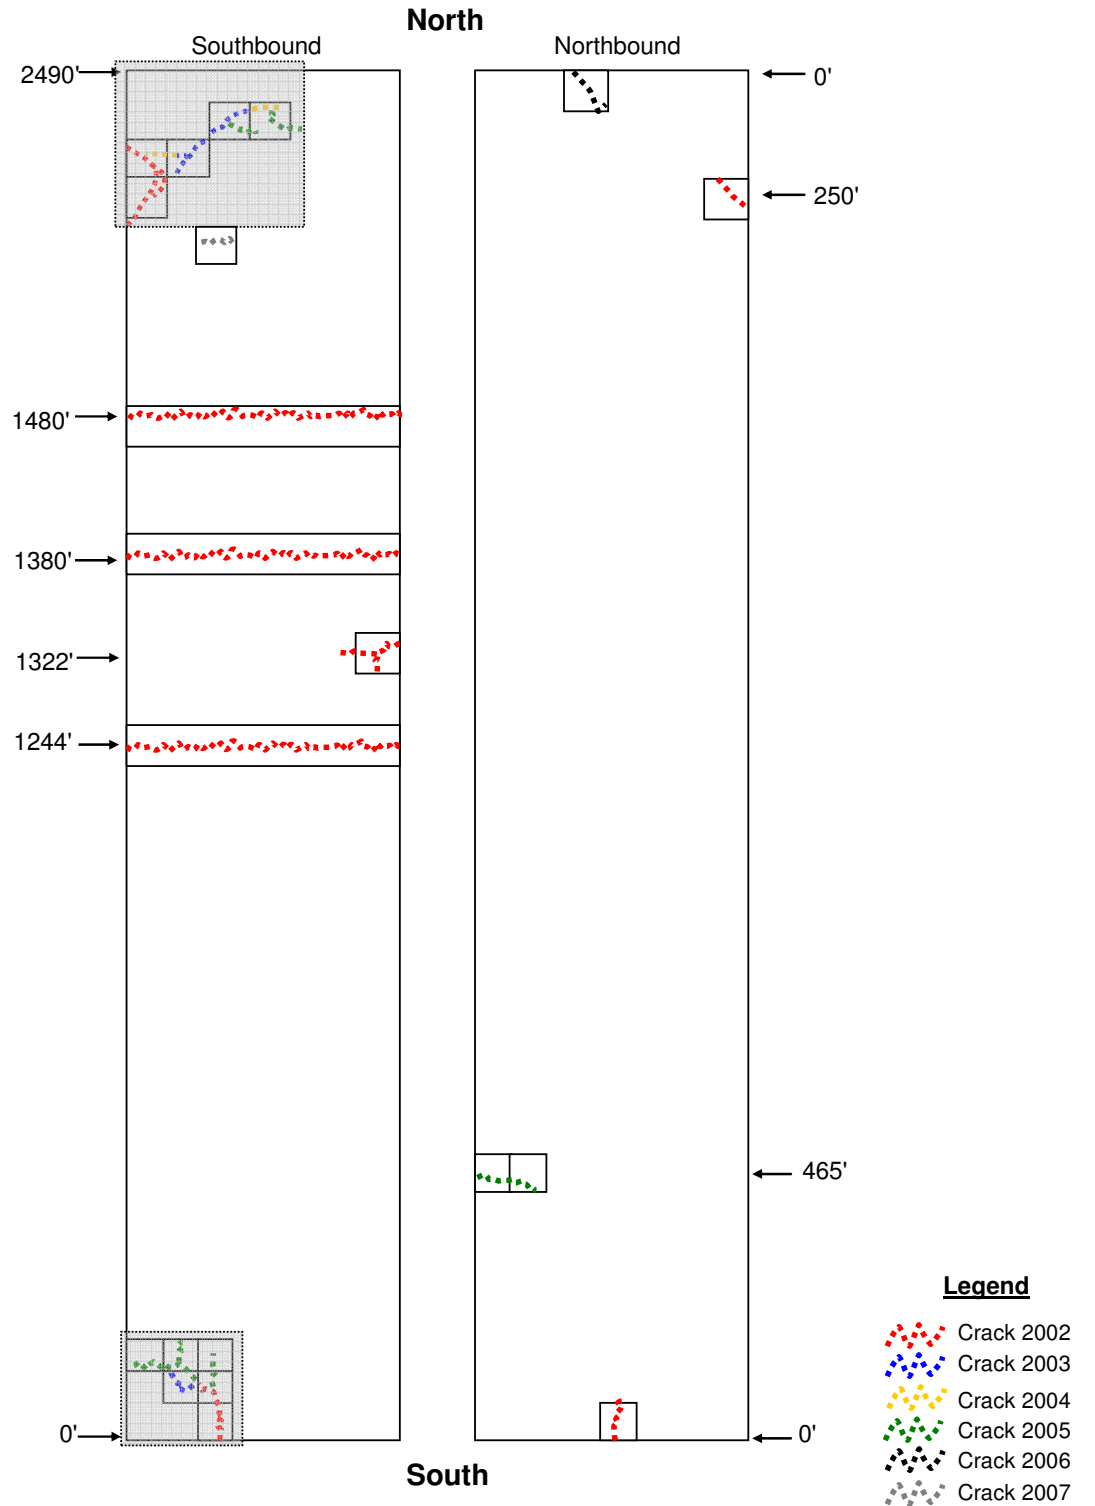
Glendive Whitetopping Representative Crack Map

A visual inspection of the entire project was performed to document all types of surface cracking and distress. Photographic documentation of some of the cracks, recent repairs, as well as a representative crack map is included in this report. Note that the crack map is strictly an interpretation of progressive distress during the evaluation phase of the project, it is not to scale. Currently three transverse cracks are present on this project, all in the southbound lane. Location as follows (footage counted from the south end of the project going north), #1 at 1244' (541m), #2 at 1380' (420m), and #3 at 1480' (451m), see crack map at end of report. Note that these cracks developed soon after placement
